A fuzzy expert system in buildings serviceability

PRIETO A. J.^{1, a *}, MACÍAS-BERNAL J. M.^{1, b}, ALEJANDRE F. J.^{1, c}
and SILVA A.^{2, d}

¹ETSIE - University of Seville, Seville, Spain

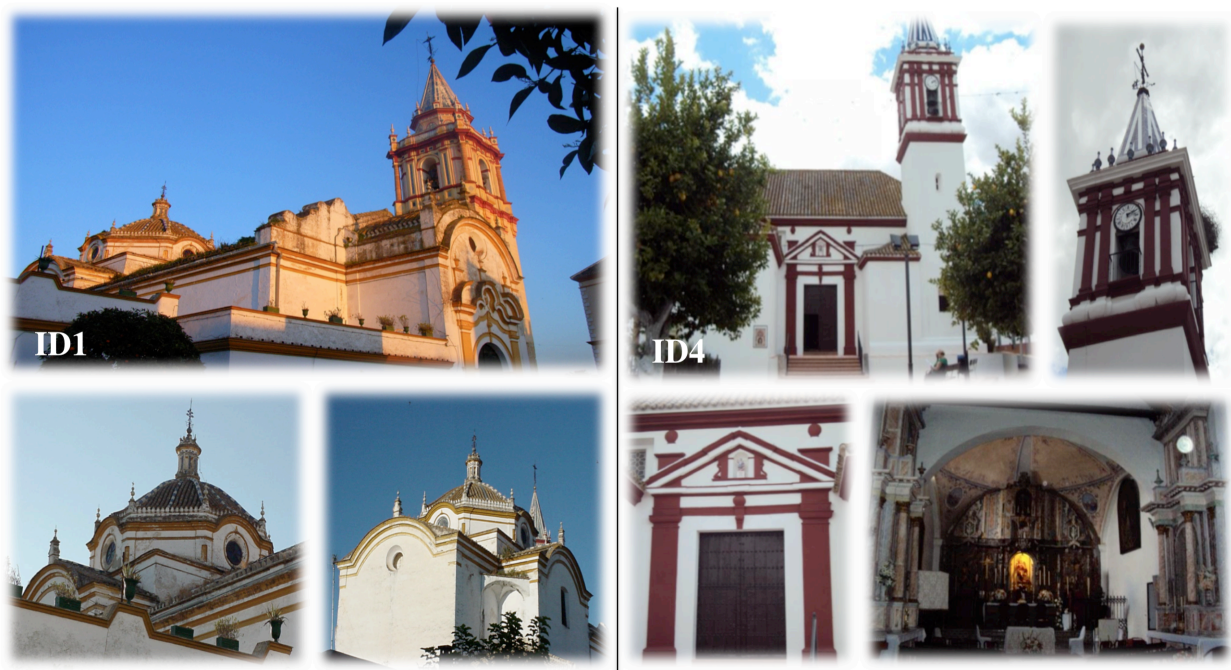
Fig. 4 Current state of ID1 San Martin de Tours' church (Bollullos de la Mitación) and ID4 San Miguel Arcángel's church (Castilleja del Campo)

These results show that the church with ID1, located at the top of the functionality ranking need more attention in terms of periodical inspections than the other buildings considered. The building ID4 at the bottom of the classifications is positioned, which is the building with the best functional level in relation with the set under analysis. In Fig. 4 the current conservation state of ID1 and ID4 are shown, it is possible to perceive in the building ID1 some degradation on the façades due to atmospheric external actions and even in the cover, where biological colonization is presented by miscellaneous plants, among other living beings (pigeons). As it is known the roof of the buildings is one of the most vulnerable parts of the constructions much more in historical building in which most of them the cover was built with timber. This constructive material is exposed to several affections, i.e. atmospheric risks (rain or temperature are ones of the mains agents in the degradation of this kind of elements) and also xylophage actions. In fact, the occurrence of anomalies in roofs usually leads to structural problems in the roof itself and in the rest of the building, and even damages in furniture and goods inside the religious buildings.
